Toby Inlet

Waterway Management Plan

May 2019

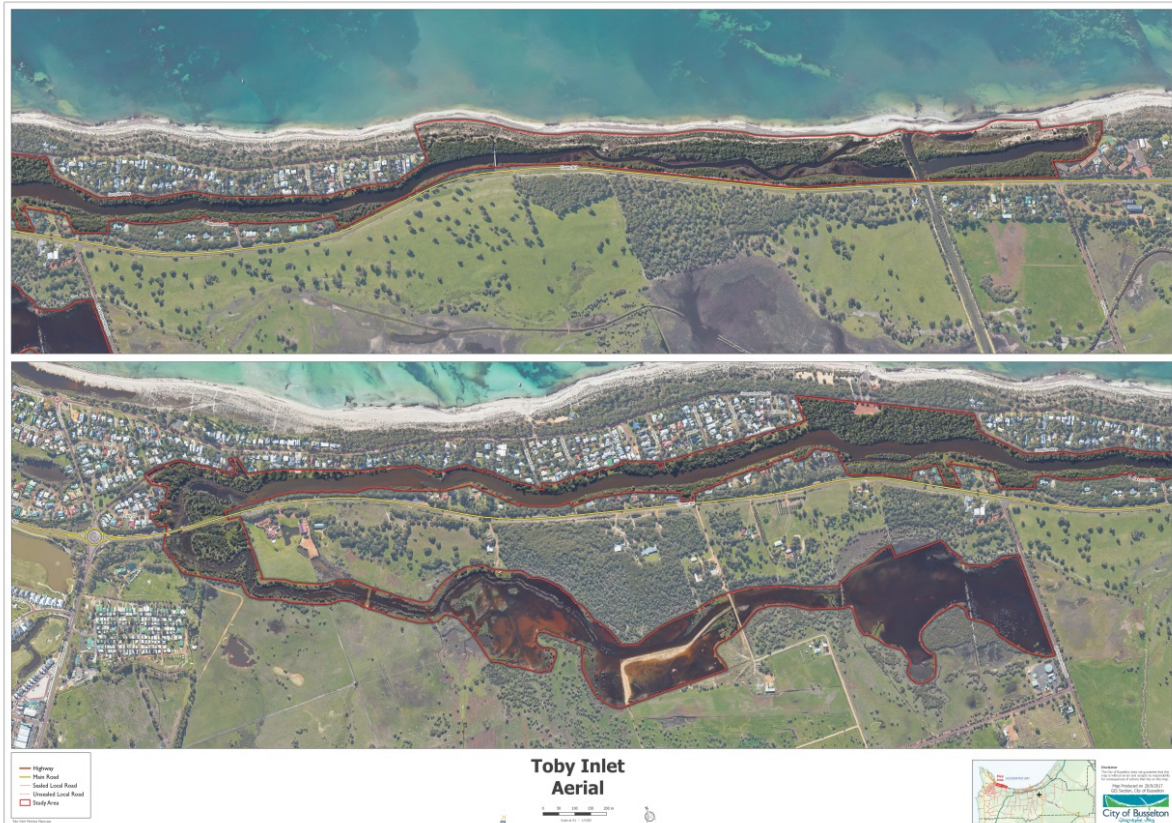
Figure 2. Toby Inlet locality and study area, and routine monitoring sites.

Toby Inlet is a small estuary near the town of Dunsborough, Western Australia, about 250 km South of Perth (Figure 2). It is narrow and elongated, extending parallel to the coastline of Geographe Bay for approximately 6 km. It is situated on the Swan Coastal Plain and is connected to seasonal wetland areas upstream. The study area for the WMP is 118 hectares, encompassing Toby Inlet itself, adjacent public reserves, and the wetland area extending upstream approximately 2.7 km from Caves Road to Quindalup Siding Road. Quindalup Siding Road acts as a physical barrier to other wetlands to the east. The study area also includes a short reach of Station Gully Drain between Caves Road and the beach (150 m), which dissects the easternmost section of Toby Inlet (500 m) commonly referred to as the Deadwater. Station Gully Drain is openly connected to the Deadwater, but is only connected to Toby Inlet via a culvert under the access road to the beach.

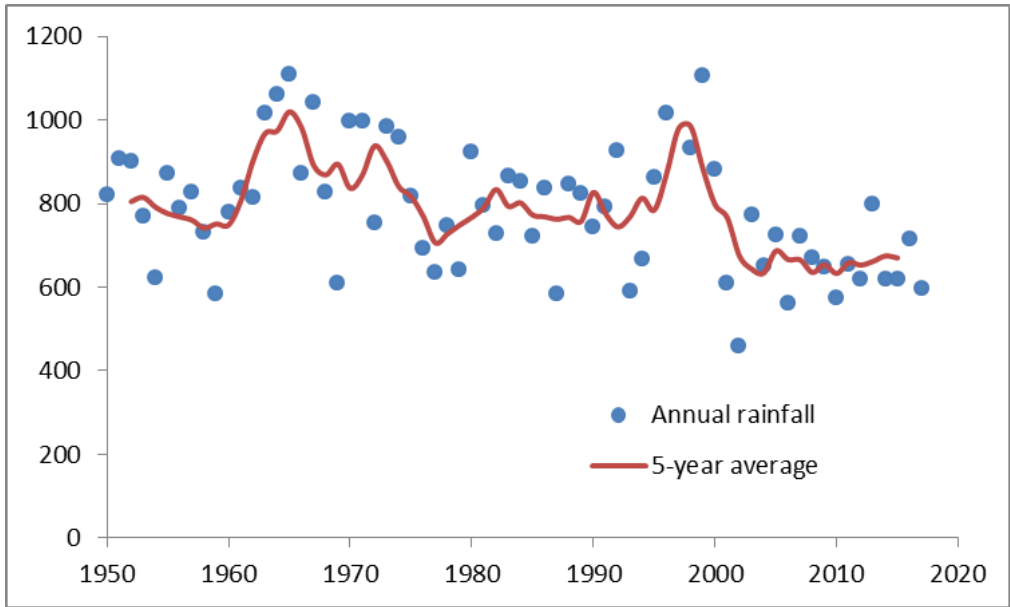
Figure 3. Rainfall records for Cape Naturaliste (BoM 2018). The 5-year average for each year includes two years before and after.

catchment is 651mm (10-year average, BoM 2018), with declining rainfall evident over the last 20 years (Figure 3).

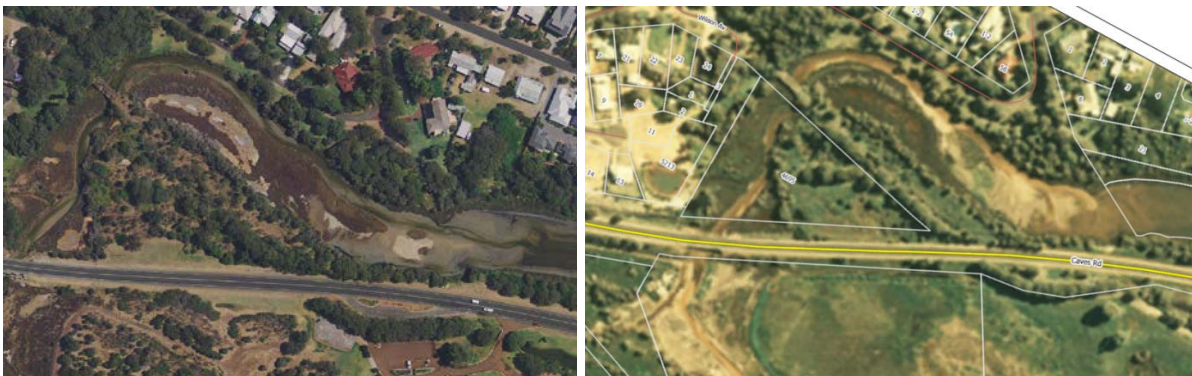
Figure 7. Comparative aerial photographs of sediment deposition in Toby Inlet downstream of Caves Road, from 2018 (left) and 1997 (right).

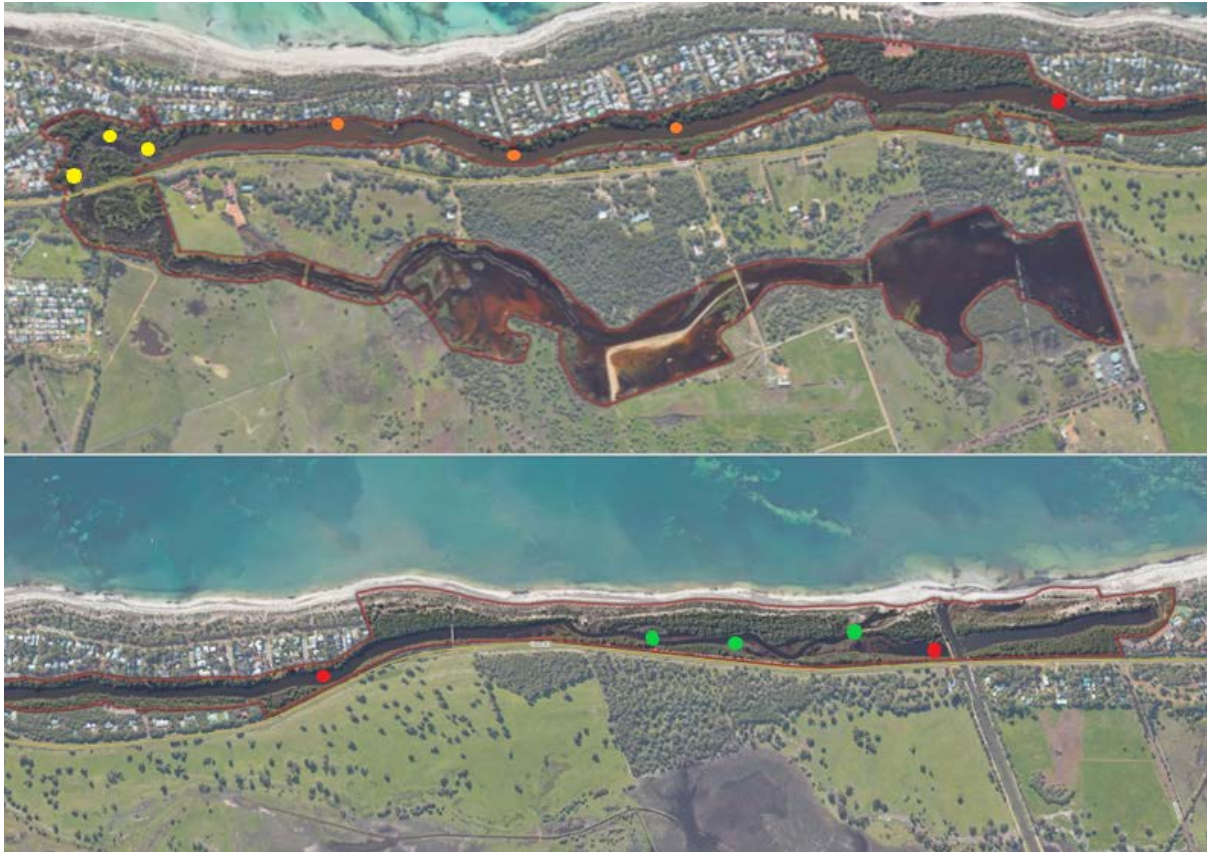
Figure 8. Acid sulphate soil and monosulfidic black ooze (MBO) presence in Toby Inlet sediments. Yellow markers show sand-dominated sediments with potential acid sulphate soils but no MBOs found in 2007 study. Orange sites show MBOs and potential acid sulphate soils in 2007 study. Green sites show no potential acidity or MBOs found in 2009 study. Red sites show MBOs and potential acid sulphate soils in 2009 study.

The deeper area downstream was assessed as having a surface layer of MBO in the sediments and also contained PASS (ENV Australia 2007). The presence of MBOs is probably linked to a history of macroalgal blooms in the area. Disturbance of MBOs can cause deoxygenation, heavy metal release, nutrient release, sulphide toxicity and bad odours.

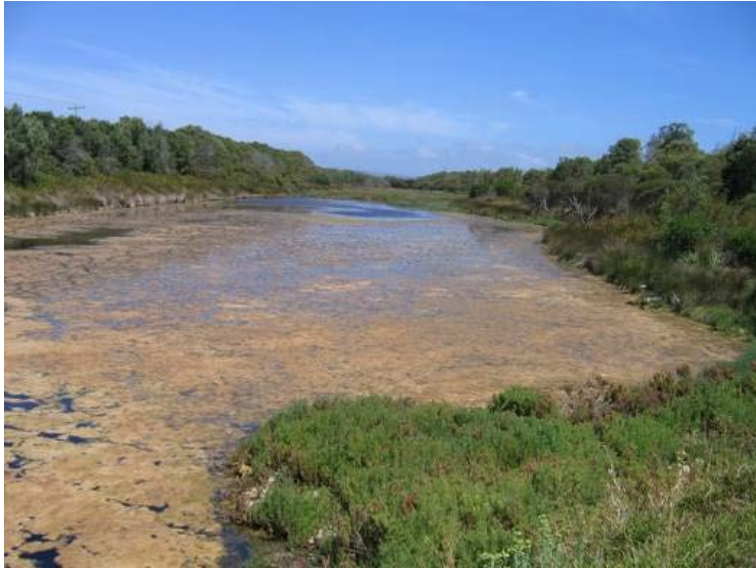
Figure 10. Macroalgae growing in Toby Inlet (DoW 2010).

Macroalgal blooms are currently more problematic than phytoplankton in Toby Inlet (Figure 10). They are not toxic but are unsightly and can cover large areas of water, restricting access and impacting visual amenity. Macroalgae also provides ideal habitat for breeding of nuisance midges. When large blooms of macroalgae decompose, this reduces oxygen levels in the water and sediments. Accumulation of this material has contributed to the formation of sulfidic sediments, including MBO. Although excessive growth of macroalgae is a serious management concern, no assessment or monitoring of species or biomass has been undertaken.

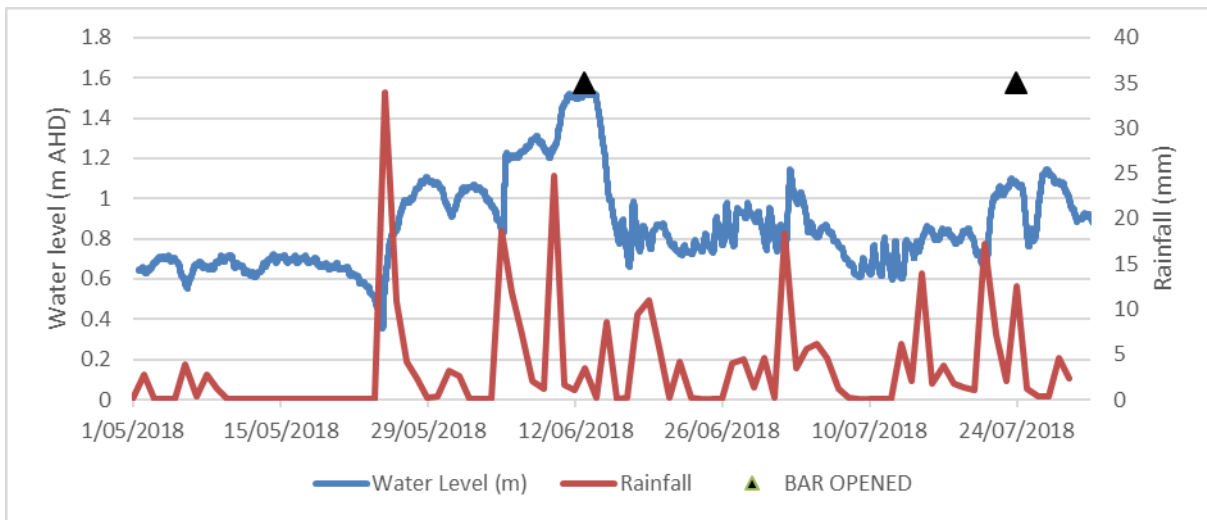
Figure 11. Water levels (blue line) at the Toby Inlet ocean outlet, daily rainfall (red line) and times when sand bar was opened (black markers) during May, June and July 2018. Rainfall data from BoM (2018).

during this time show minor flooding in adjacent lands at these water levels (Figure 12). The sand bar was opened on 13th June 2018, lowering water levels to about 0.8m within two days. This opening was effective, and the outlet remained open intermittently for about four weeks. Rising water levels initiated further opening of the sand bar on 24th July when water levels were around 1.1m. In this instance the sand bar closed within two days.

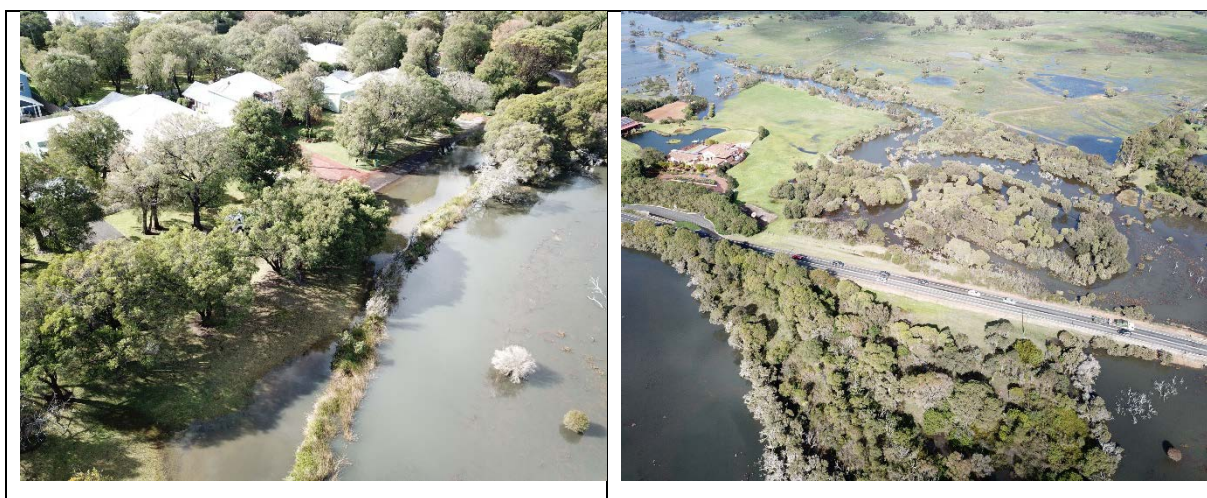
Figure 12. Photos showing minor flooding in the vicinity of Toby Inlet from 11th - 13th June 2018.

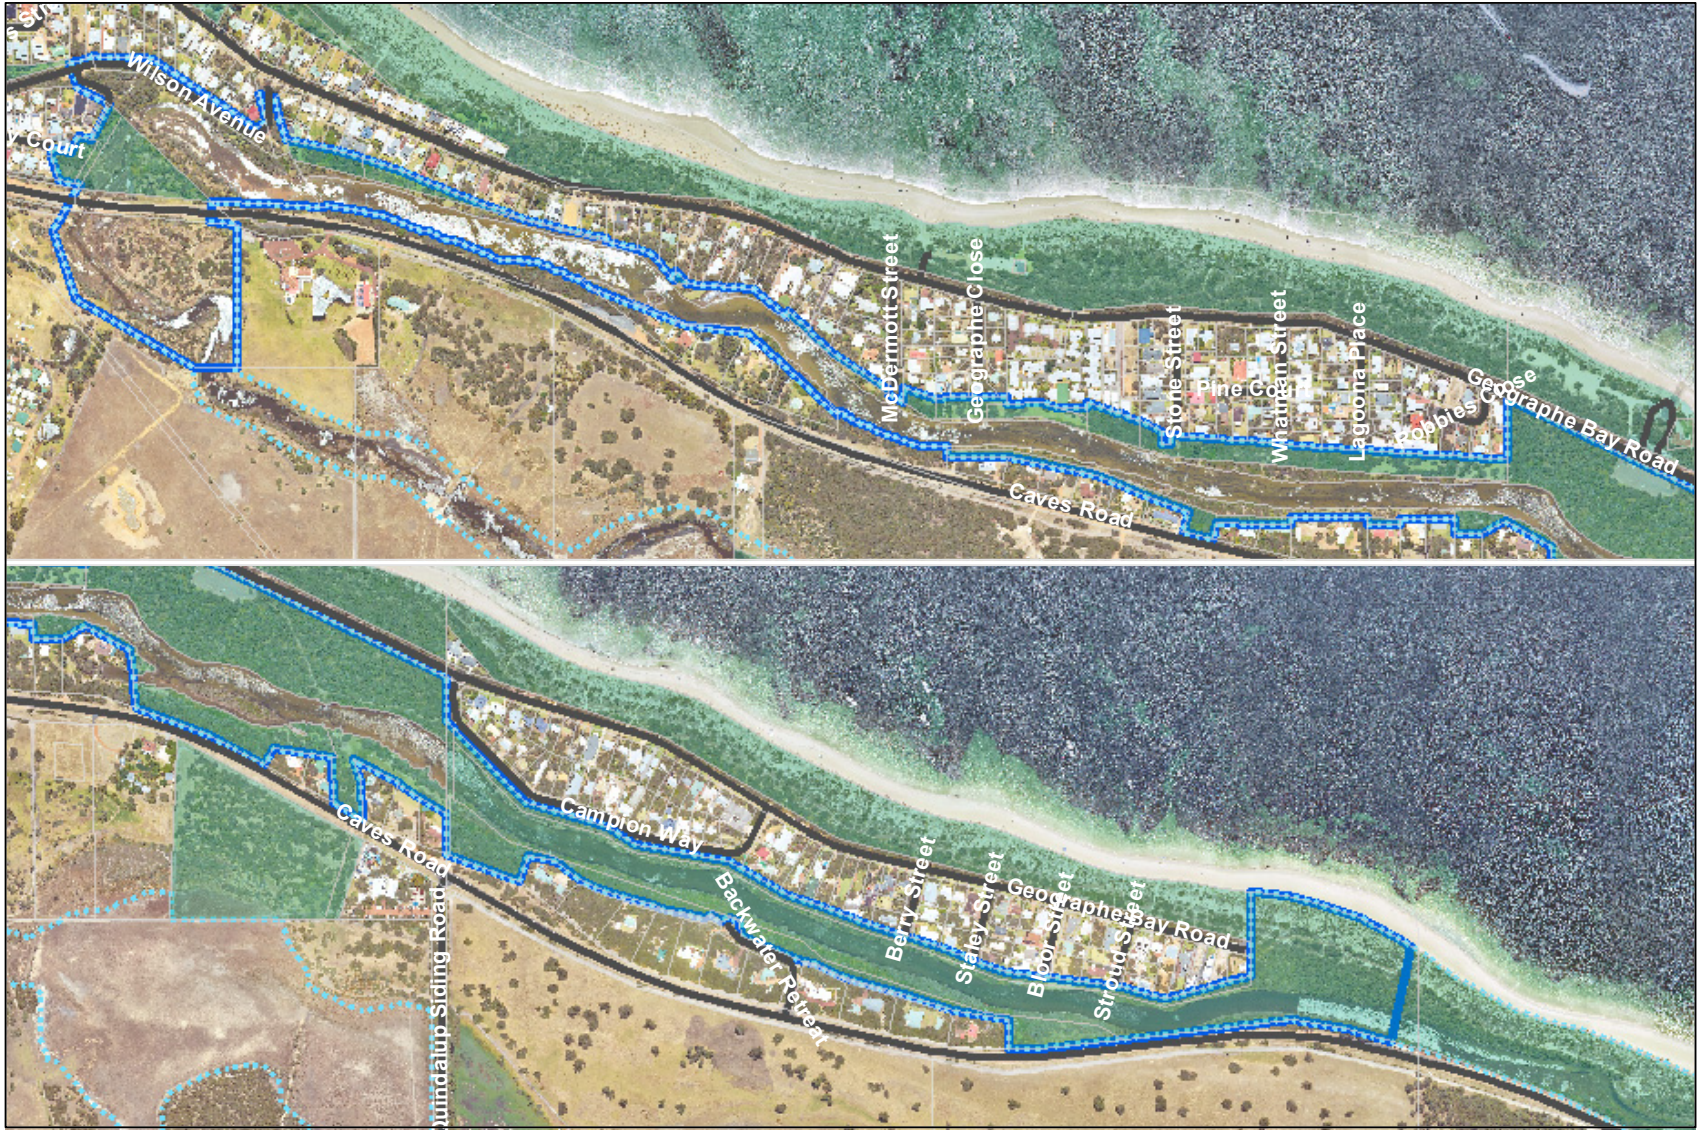
Figure 1-1 Toby Inlet study area

The study area includes the areas of Toby Inlet from the south western corner of the Palmers Estate downstream to the foot bridge crossing on Caves Road just east of the residential area of Quindalup. There was a preference to focus on the northern side of Toby Inlet. The study area is shown in Figure 1-1.

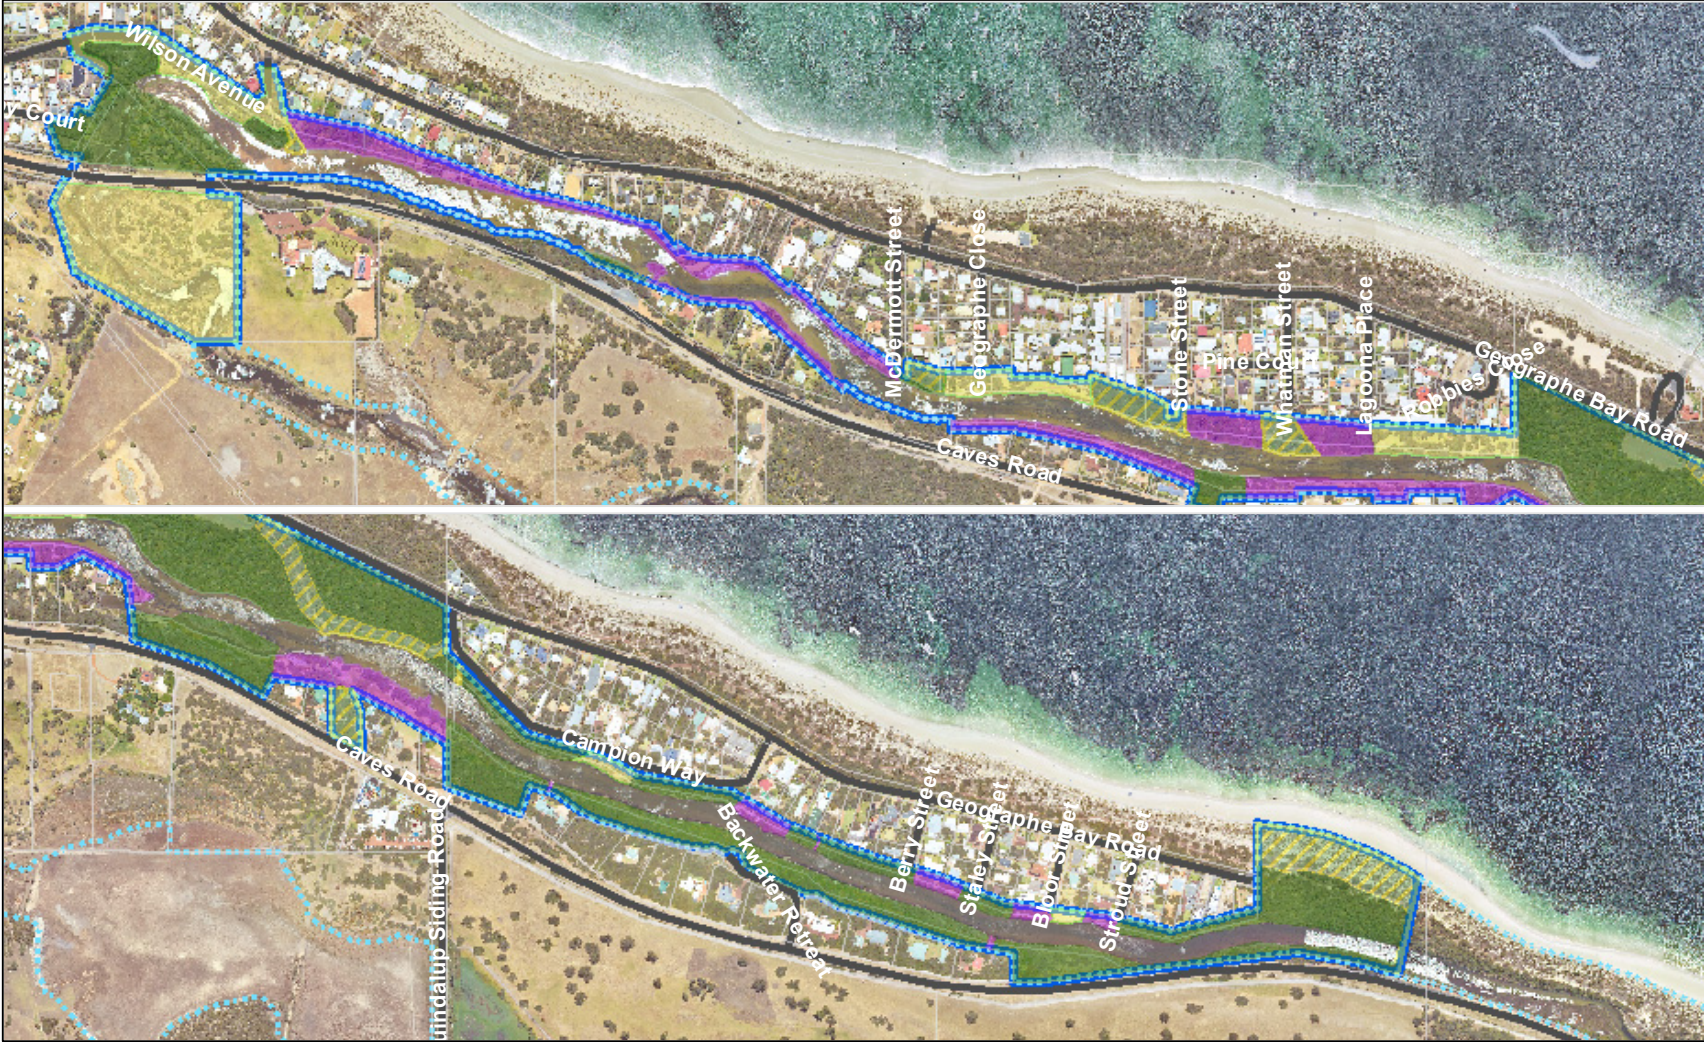
Figure 3-1 Toby Inlet access management precincts

These are mapped in Figure 3-1 (detailed in Appendix A) and are described below. Additional location specific recommendations, such as track closures and revegetation opportunities are also made in the Appendix.

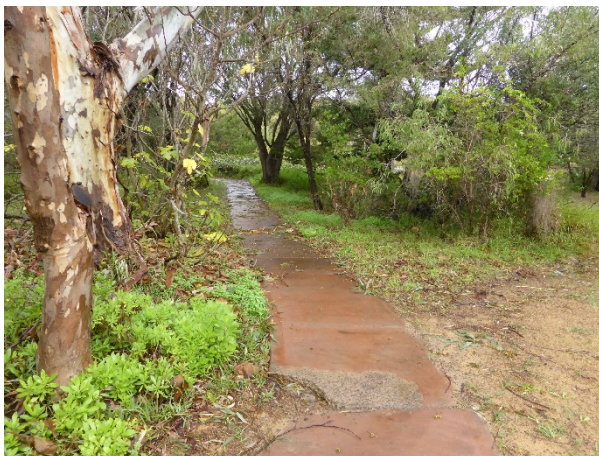
Figure 3-2 Existing path south of Geographe Close needing repair.

With the exception of the Geographe Bay foreshore walk and footbridge east of Geographe Bay Road, most of these tracks are in need of maintenance or could be improved with either a 1.2m (or City standard) red hot mix seal in the high traffic areas or those at risk of flooding (e.g. foreshore areas), or compacted limestone along the firebreaks. Formalising tracks would encourage use and contain potential impacts that might otherwise occur (e.g. minimise trampling along the edges). Some existing areas need to be repaired (e.g. existing concrete path south of Geographe Close, shown in Figure 3-2). Location specific management recommendations are provided in Appendix A.

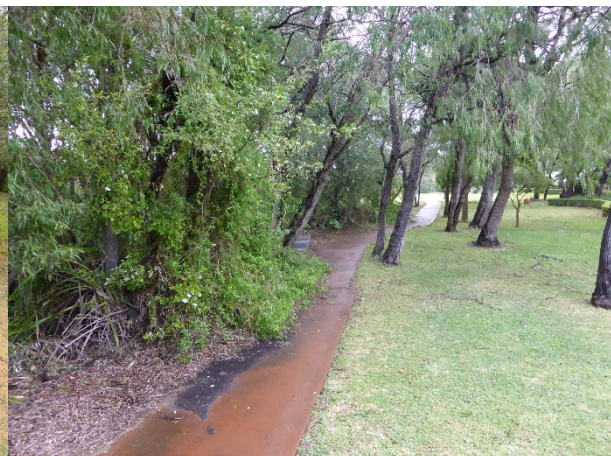
Figure 3-3 Existing path near Stone Street requiring maintenance.

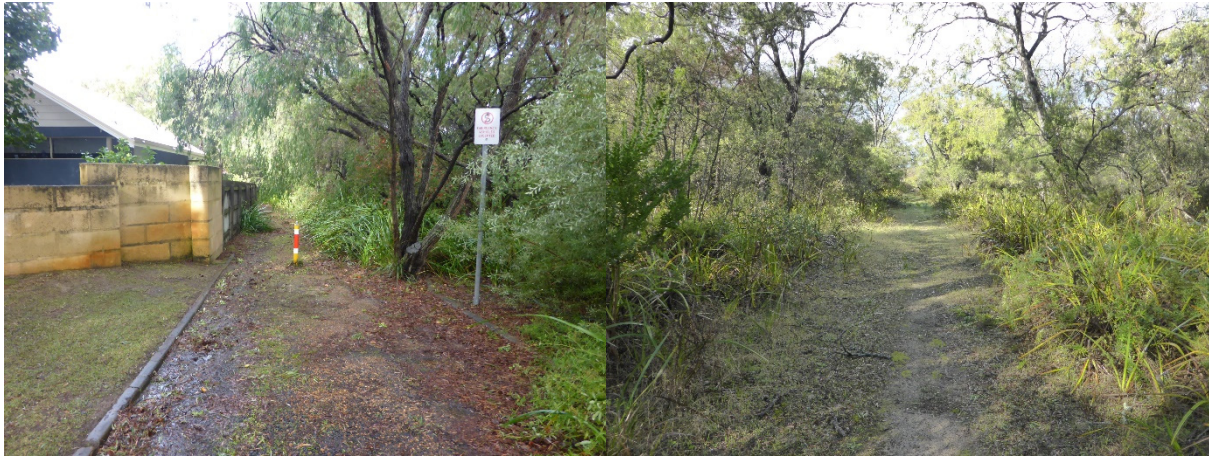
Figure 3-4 Emergency access off Lagoona Place that could be improved with new hot mix.

Figure 3-5 Firebreak from the Boat Club overflow carpark to Champion Way that could be formalised with compacted limestone.

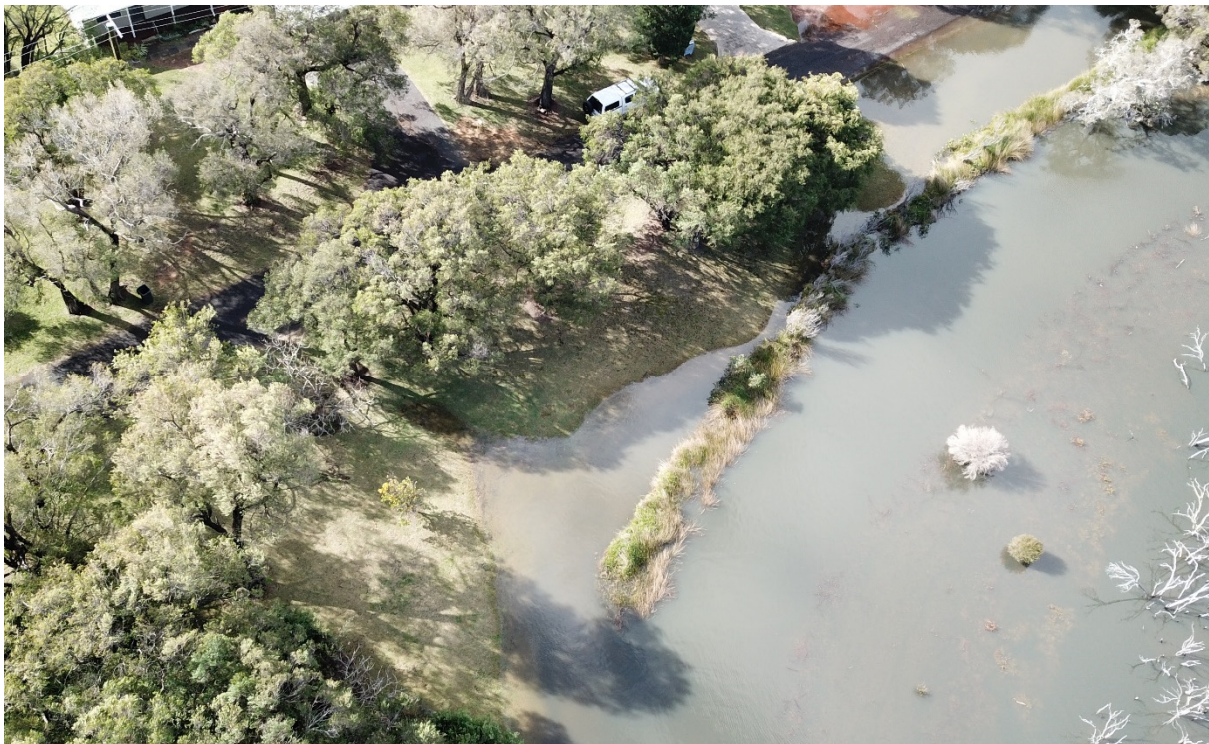
Figure 3-7 Maintained parkland at Wilson Avenue where a defined pathway would define the reserve boundary and protect fringing vegetation.

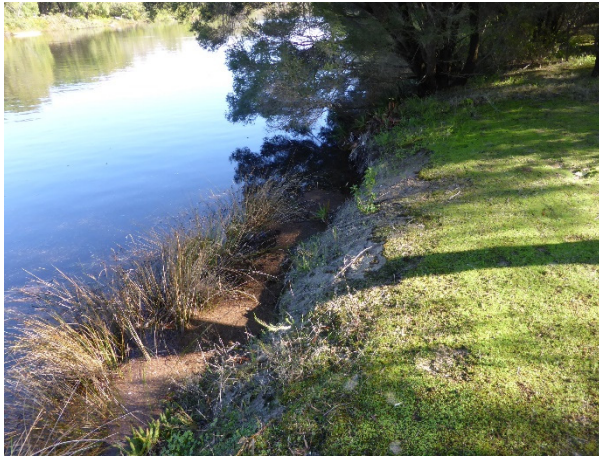
Figure 3-8 Example of erosion at Mc Quade Park (Campion Way) due to loss of stabilising foreshore vegetation.

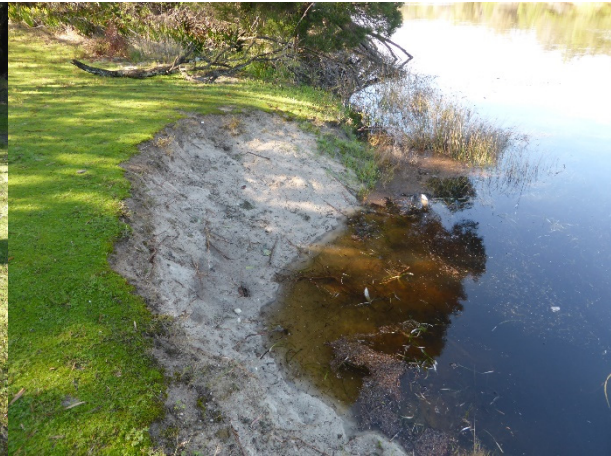
Figure 3-9 Example of erosion at Mc Quade Park (Campion Way) due to loss of stabilising foreshore vegetation.

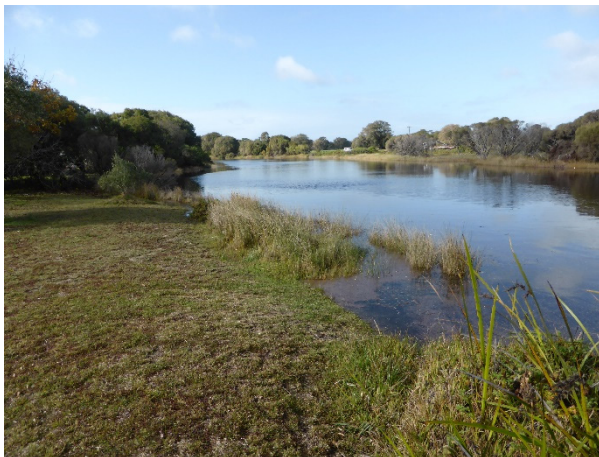
Figure 3-10 Cleared area off Bloor Street.

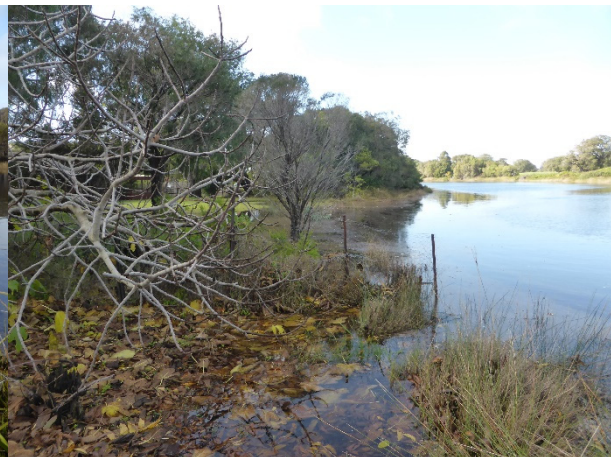
Figure 3-11 Cleared area off Bloor Street showing clearing from adjacent landowner and fencing to the water edge.

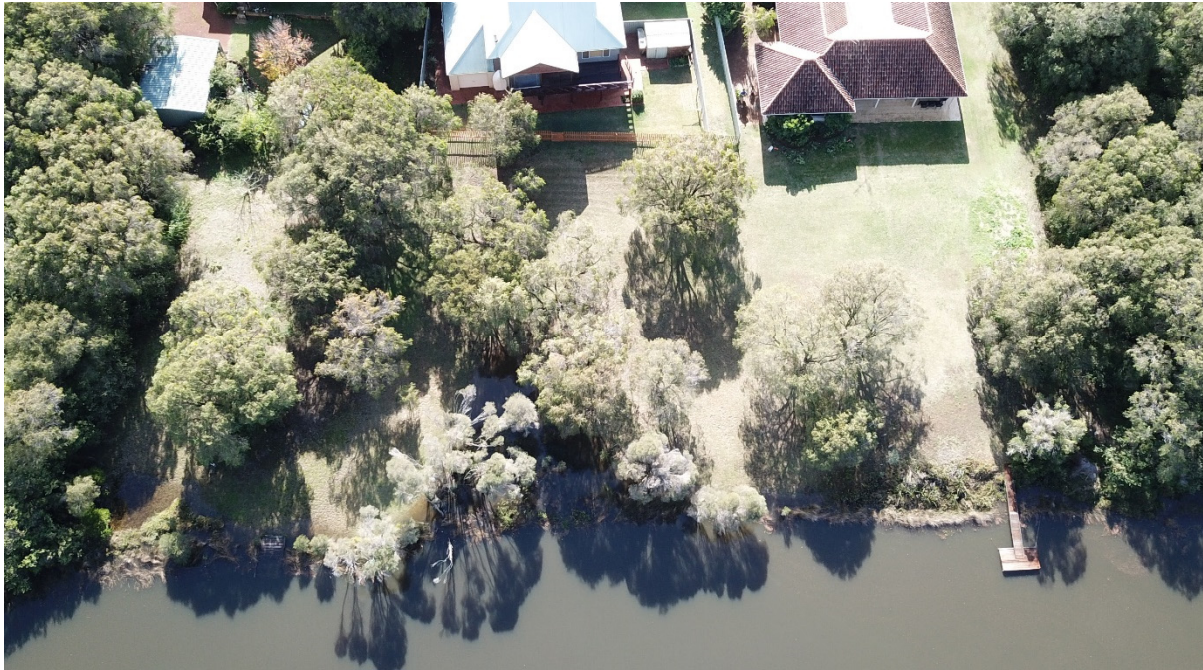
Figure 3-12 Example of restricted access and private property adjacent to the reserve.

These areas will be a challenge to the City in terms of ensuring appropriate foreshore management and will likely be addressed in the broader Water Management Plan. There are several sections that could be used by the public where a landowner(s) could be contacted, but in isolation and without connectivity to other pathways, they are limited in what they can offer in this Plan.

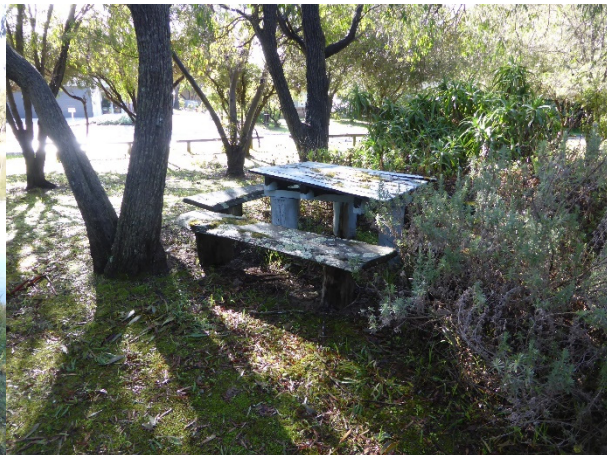
Figure 3-18 Derelict table (WP 8)

These are shown in the photos below. There are a number of pontoons and other informal structure private property structures that may require inspection and assessment by the City as to whether they should be removed due to a public liability risk (risk delegation signage might be more appropriate than removal).

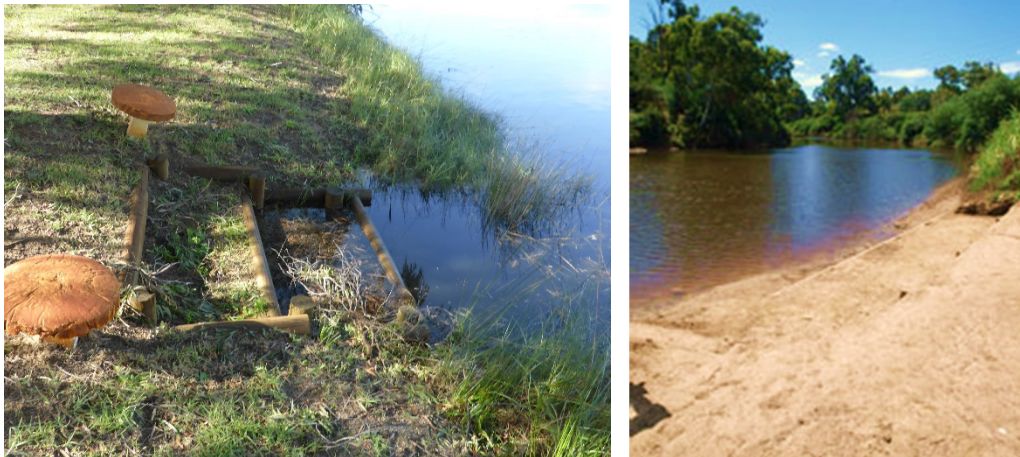
Figure 3-19 Examples of stepped retaining walls that could be enlarged for canoe access, or as a fishing platforms in degraded areas.

- Close access to parking,
- Located downstream enough so that water levels are adequate for most of the year,
- Ensure the natural bank is stabilised,
- Ensure construction materials will withstand periodic inundation,
- Include appropriate signage,
- Alternative use as a fishing platform.

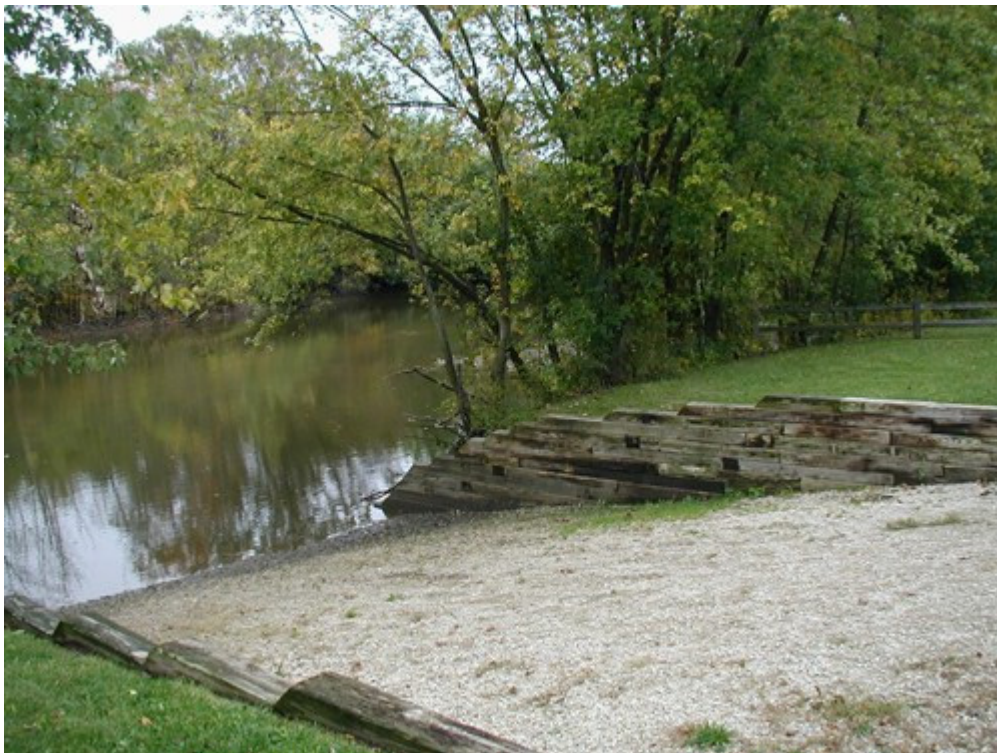
Figure 3-20 Example of graded access to the water mark. Note that retaining walls would still be required at the bank cutting. Source: <https://www.lcfd.org/launches/>

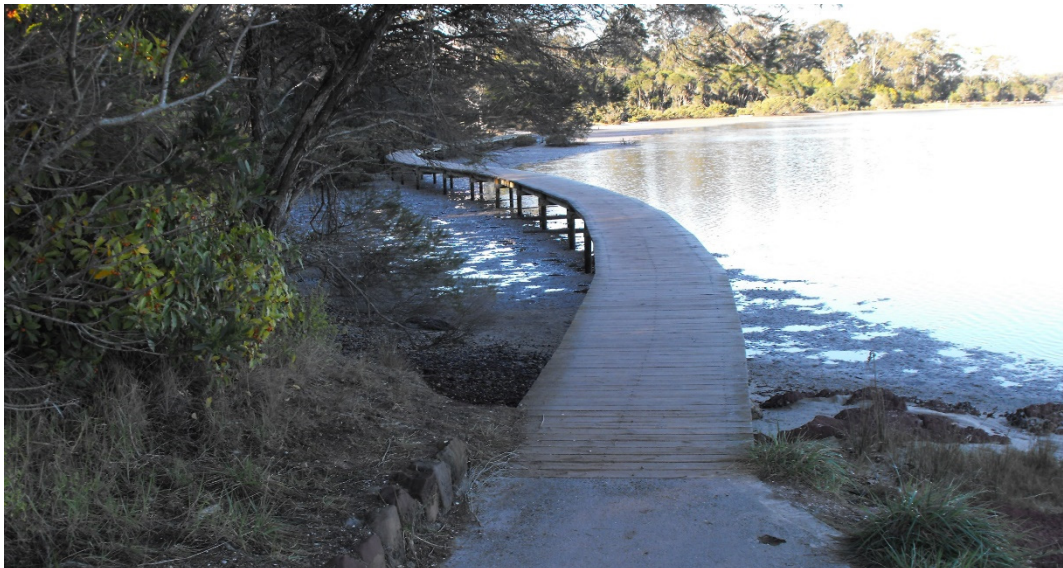
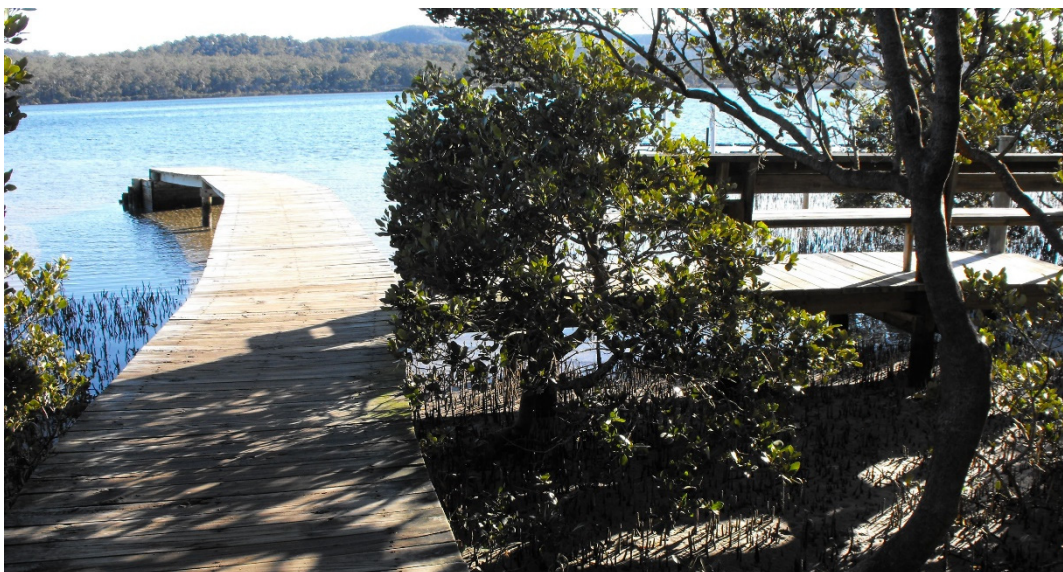
Figure 3-21 Boardwalk examples around Bottom Lake, Merimbula

These are low key features, relatively cheap to build, with low construction impacts if constructed during summer low water level months (with little or no clearing required). They have been adopted with high success by other local governments in high value sensitive coastal lake locations such as Bottom Lake, Merimbula (Bega Valley Shire Council) (see Figure 3-21) and Narooma Foreshore (Eurobodalla Shire Council). A starting point for the installation of a boardwalk might be the 100m and 70m private property sections between Stone Street and Lagoon Place, which would then enable a continuous pathway of about two kilometres long.

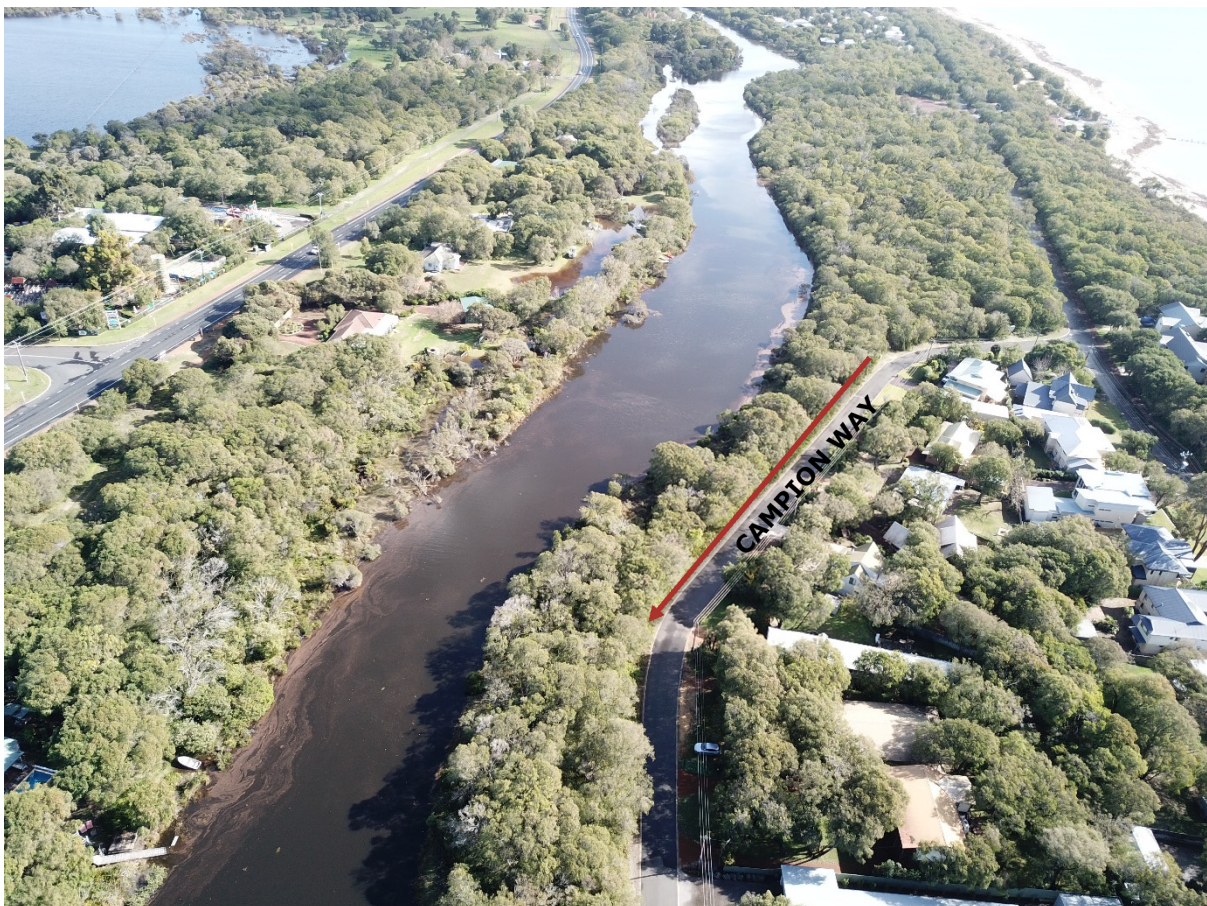
Figure 3-22 Clearing required for a pathway along the southern Campion Way roadside (see red line).

An example would be the construction of a pathway along Campion Way road reserve linking Mc Quade Park to the east to the existing pathway off Campion Way to the Boat Ramp parking lot. Low impact clearing of sword sedge would be required.
